Technical Report REMR-CS-44
June 1994

Repair, Evaluation, Maintenance, and Rehabilitation Research Program

Field Testing and Structural Analysis of Vertical Lift Lock Gates

by Brett C. Commander, Jeff X. Schulz, George G. Goble Bridge Diagnostics, Inc.

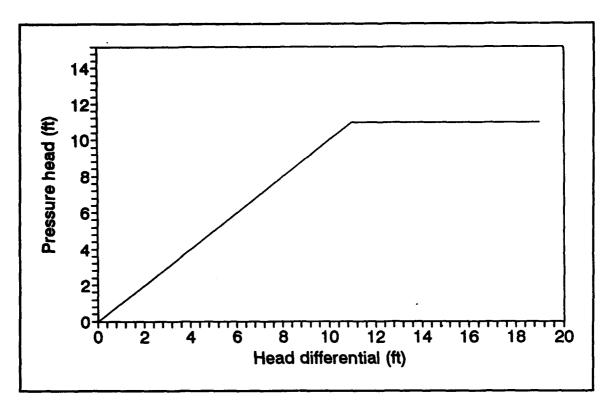
a. Vertical loading. The top girder web of a submerged lift gate leaf forms a horizontal damming surface. The magnitude of the head differential vertical load is dependent on the difference between the pressures acting on the upper and lower surfaces of the girder web. Pressure due to the hydrostatic head of the upper pool acts on the upper surface and when the chamber pool elevation is above the top girder, pressure due to the hydrostatic head of the chamber pool acts on the lower surface. When the chamber pool level is below the top girder, the pressure on the lower surface is zero. As the chamber pool is dropped from the upper pool elevation to the top girder elevation, the vertical load increases proportionally with the head differential. As the chamber pool continues to drop, the vertical load is dependent only on the upper pool elevation. A graph of the vertical load pressure with respect to head differential for this test is shown in Figure 57. The loading consists of a linearly increasing force up to a head differential of approximately 11 ft (3.35 m) (difference between upper pool and top girder elevations) and is then constant for the remaining chamber drop.

Figure 57. Vertical load pressure as a function of head differential

b. Structural response. All of the strain histories obtained from the diaphragms and diagonal braces have the same shape as the vertical loading shown in Figure 57. Although the head differential horizontal load continues to increase as the chamber pool drops below the top girder (approximately 11-ft (3.35-m) head differential), the strains remain relatively constant for head differential greater than 11 ft (3.35 m). This indicates that these elements are primarily affected by the vertical loading only. Therefore, it is reasonable to assume that the crack at the girder and diaphragm flange interface may be caused by deflections induced by the vertical loading.

Under vertical loading, deflection induced stresses may have contributed to the formation of the crack at the girder and diaphragm flange interface. If sufficient horizontal shear resistance were present between each girder, the entire leaf would act as a large beam under distributed vertical load. The gate leaf would bend in the plane of the leaf about its neutral axis with the upper girders subject to compression and the lower girders subject to tension. This type of response is described by the Euler-Bernoulli beam response in which plane sections remain plane and perpendicular to the neutral axis. Given this type of response, the diaphragm members would remain straight and would rotate to remain perpendicular to the girders. However, as indicated by recorded strains data, the deformation of the gate leaf was more representative of shear deformation in which vertical planes tend to remain vertical.

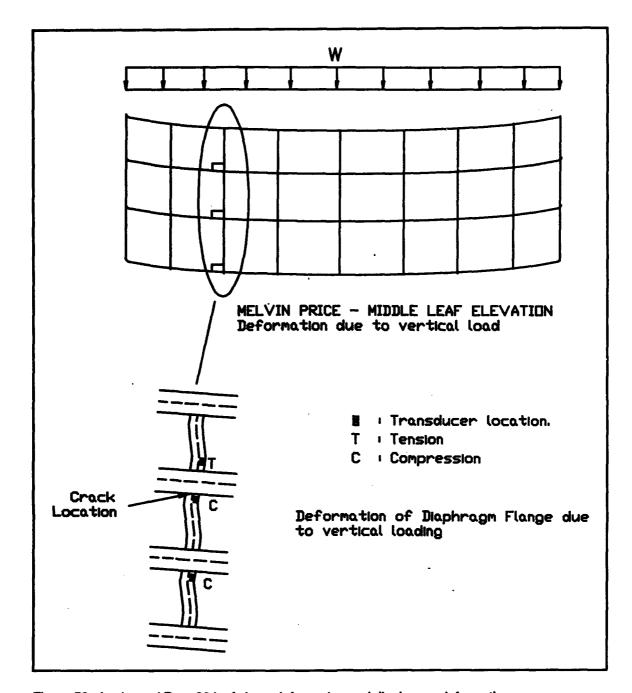
- c. The diaphragms are forced to deflect in double curvature (S-shape) to maintain continuity with the girder flanges at each end of the diaphragm. This deformation results in large tensile (and compressive) stresses at the ends of the of the diaphragm flanges (Figure 58) and large shear stresses along the length.

Figure 58. Locks and Dam 26 leaf shear deformation and diaphragm deformation

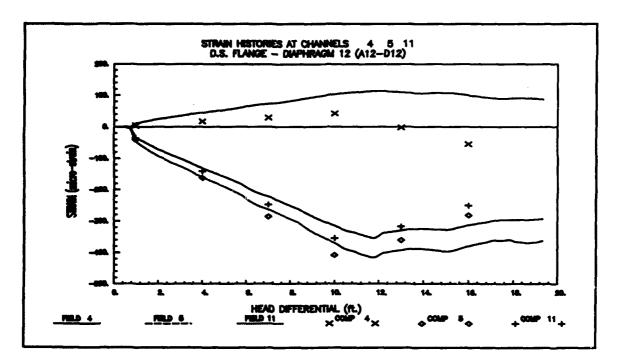
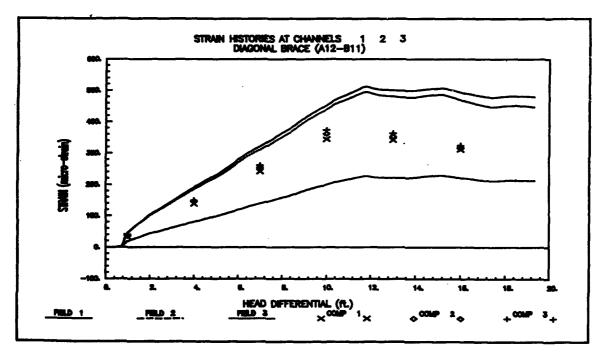
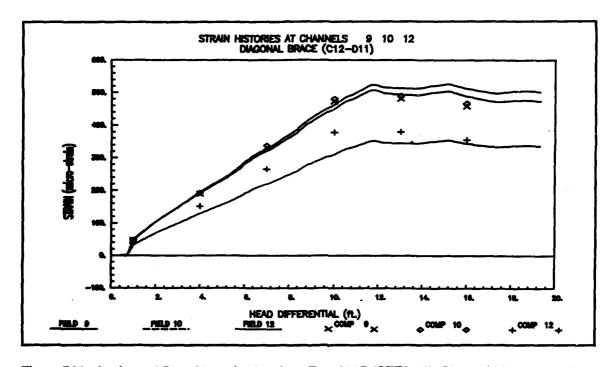
SET2-26. To study the effect of the cracked diaphragm, the analytical strains were compared to the measured strains of the SET2-26 (Figures 46 through 50) chamber drop test (Test 262B). Strain-history comparisons for Test 262B are provided in Appendix B, Figures B27 through B30. Similar to SET1-26 results, the comparisons for axial behavior of the bracing elements are acceptable, while the comparisons for flexural behavior are poor. Review of the diaphragm flange strain data yields some interesting insight regarding head differential vertical loading. The structural response due to vertical loading provides an explanation for the occurrence of cracking in the flange plate.

Figure B27. Locks and Dam 26 strain histories - Test 262B (SET2-26), Channels 4, 5, and 11

Figure B28. Locks and Dam 26 strain histories - Test 262B (SET2-26), Channels 1, 2, and 3

Figure B30. Locks and Dam 26 strain histories - Test 262B (SET2-26), Channels 9, 10, and 12

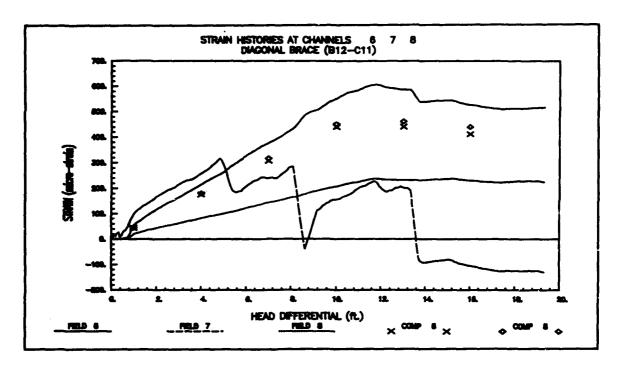
Figure B29. Locks and Dam 26 strain histories - Test 262B (SET2-26) (gage slippage on channel 7), Channels 6, 7, and 8
